**Flood Control Project Maintenance
Levee Inspections**

Fall 2016 Levee Maintenance Deficiency Summary Report

Sacramento River Basin

Reclamation District No. 0784 Plumas Lake

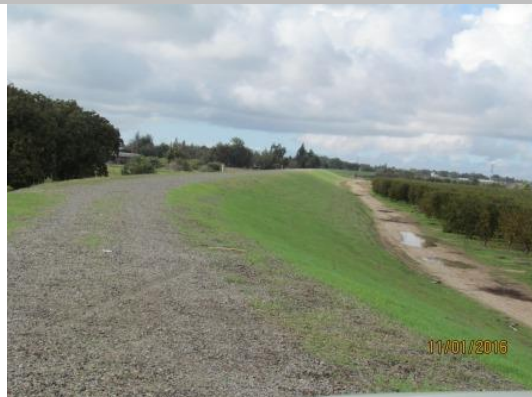
Photo 1 of 1 : FA_2016_RD0784_178_2_20161103_00006.jpg

View of waterside looking downstream of well maintained annual vegetation. Fall 2016.

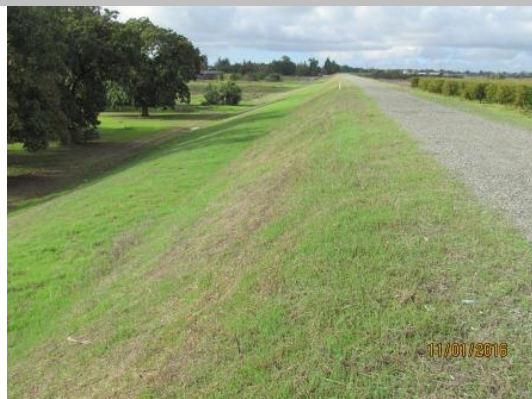
Photo 1 of 1 : FA_2016_RD0784_178_3_20161103_00007.jpg

View of landside looking downstream of well maintained annual vegetation. Fall 2016.

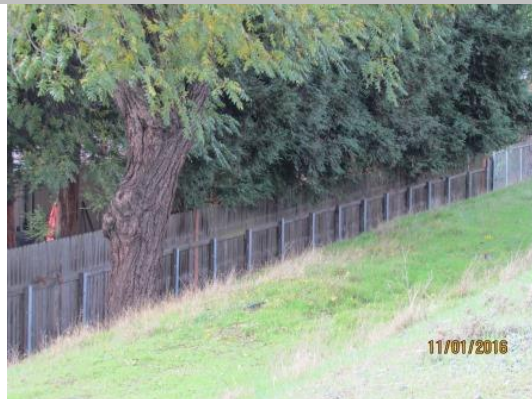
Photo 1 of 1 : FA_2016_RD0784_178_12_20161103_00008.jpg

LM Start	0.51	Rating **	M	Issue No.	12
LM End	1.00	Issue Type +	En	Location *	LS
Category	Earthen Levee			GPS Latitude/Longitude	
				Start	End
Item	Encroachments			39.131558 °	39.129475 °
				-121.560668 °	-121.569209 °
DWR ID	DWR_RD0784_01_f_2012_12				
Comment Code					
FE : Fence					
Inspector Comment					
Fences are found within the 10 feet of levee easement .

Fences were found on the landside toe of the levee looking downstream. Fall 2016.

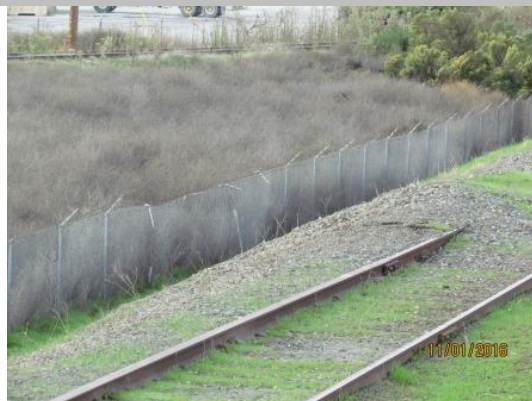
Photo 1 of 1 : FA_2016_RD0784_178_13_20161103_00009.jpg

LM Start	1.00	Rating **	M	Issue No.	13
LM End	1.12	Issue Type +	En	Location *	LS
Category	Earthen Levee			GPS Latitude/Longitude	
				Start	End
Item	Encroachments			39.129475 °	39.129615 °
				-121.569210 °	-121.571371 °
DWR ID	DWR_RD0784_01_f_2012_13				
Comment Code					
FE : Fence					
Inspector Comment					
Fence near the levee toe. Fall 2016.

This photo shows a fence near the levee toe on the landside looking downstream. Fall 2016.

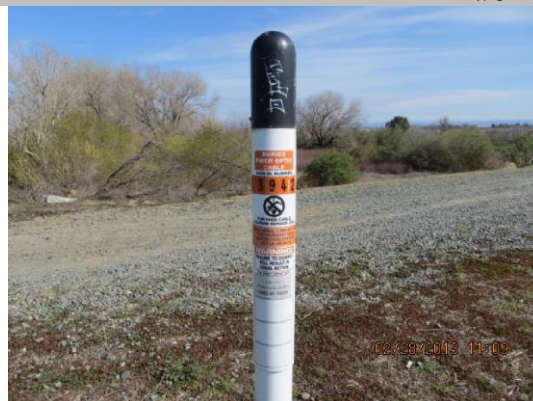
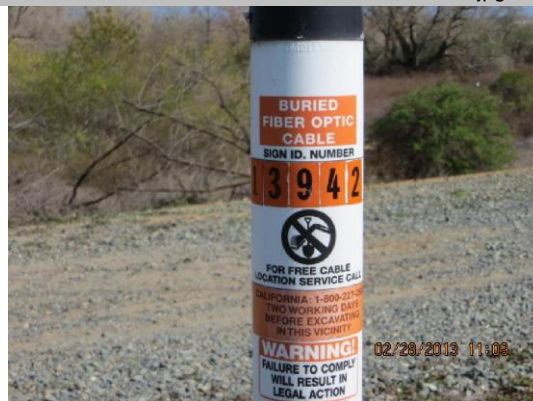
FS_ID:50677
DS_ID:18552
EP_NO: N/A
Repair Type: Non-Urgent
Crossing Status: Indicator Found
UCIP Comments: 11/15/2016 - Crossing is still Non-Urgent due to the possibility that the pipe is unpermitted. The crossing will be downgraded when owner provides permit or CVFPB enforcement resolves the issue. (DWR UCIP - thatch)11/01/2015 - Letter requesting permit or to provide permit sent to owner Century Link, 700 W. Mineral Avenue, Rm D 27.34, Littleton, CO 80120 on 2/18/2014. Pending CVFPB enforcement on utility crossing owner. Requesting DWR inspector to change the status of this issue to "No Action Needed" (P. Meagher - RD784) 02/28/2013 - No permit identified for this crossing. Need to determine if owner has permit. (W.Wylie UCIP Inspector).
FIELD_STRUCT_DESC: Fiber Optic Communication lines cross levee. Diameter unknown.
FS Date: 9/11/2015 9:08:00 AM

Marker on east side of Rail/WS of Levee.

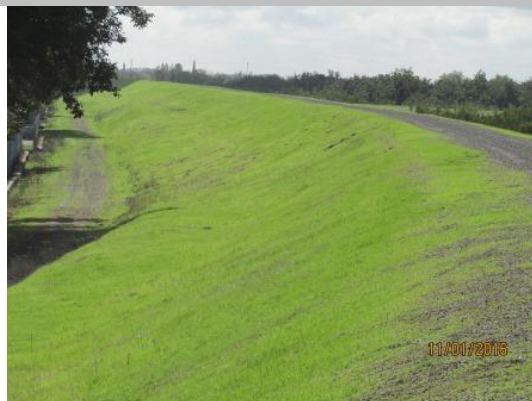
Photo 1 of 2 : FA_2016_RD0784_531_1_20161103_00005.jpg

First view looking downstream of landside well maintained annual vegetation. Fall 2016.

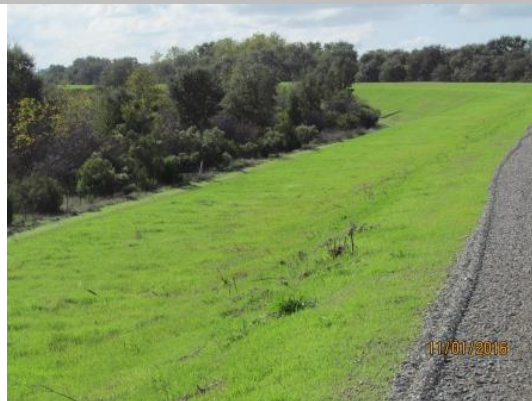
Photo 2 of 2 : FA_2016_RD0784_531_1_20161117_00007.jpg

Second view looking downstream on waterside of well maintained annual vegetation. Fall 2016.

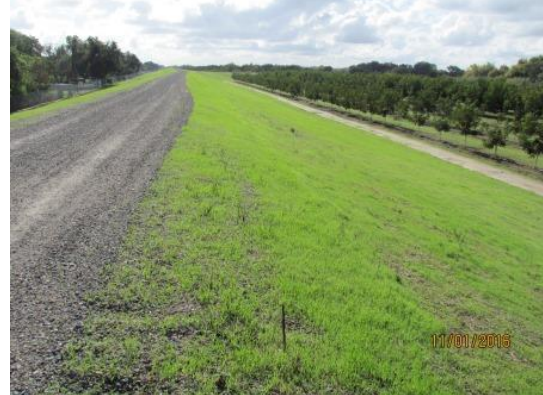
Photo 1 of 2 : FA_2016_RD0784_531_2_20161103_00003.jpg

First view of waterside looking downstream of well maintained annual vegetation. Fall 2016.

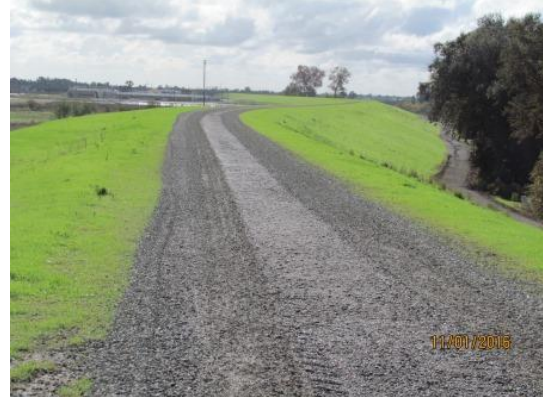
Photo 2 of 2 : FA_2016_RD0784_531_2_20161103_00004.jpg

Second view of waterside looking downstream of well maintained annual vegetation. Fall 2016.

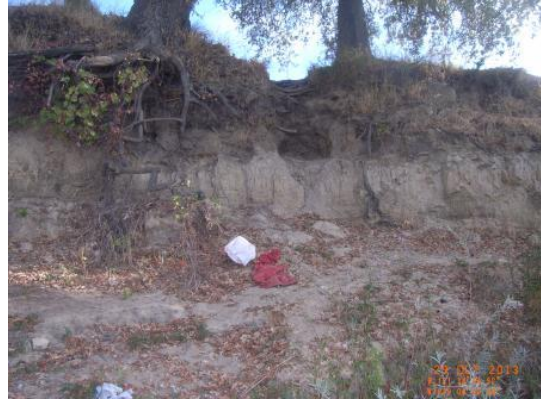
USACE 2013 Photo #1

Comment Code					
Inspector Comment					
2003 - Bank is near vertical. Identified as a Potentially Critical site. 2004 - Eddy flow off downstream end of Modesto formation eroding the fluvial sediments. 2005 - Some new slumping. Actively eroding but berm width is greater than 50 ft. 2006 - Downgraded to regular erosion site. Still actively eroding. Large old rotational failures in high bank on the downstream end. 2008 - Removed from inventory due to wide berm width does not meet criteria for an erosion site. 2010 - Added back to the inventory after 10 ft of bank erosion in the winter 2009 storm. Steep vertical face. 2011 - Bank has retreated an additional 2.5 ft from last year. New tree popouts and erosion throughout the site. 2012 - Site continues to worsen with new tree popouts and many sections of new erosion. 2015: Last observed in 2013. [2015 Site ID: FHR_17-8_L]

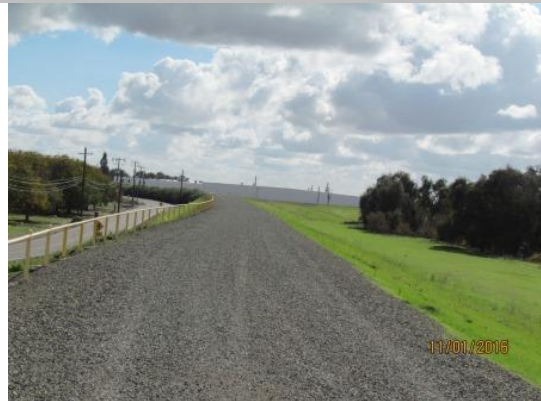
Photo 1 of 1 : FA_2016_RD0784_532_4_20161103_00006.jpg

Second view of waterside looking downstream at well maintained annual vegetation. Fall 2016.

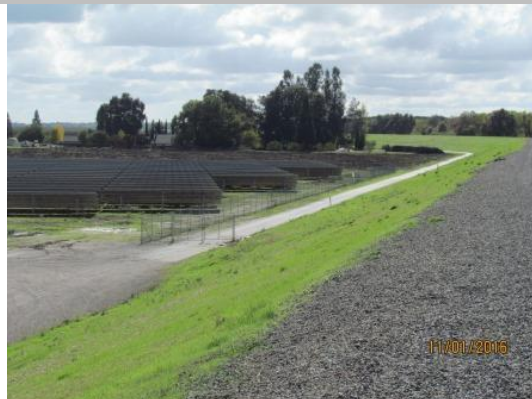
Photo 1 of 1 : FA_2016_RD0784_532_3_20161103_00007.jpg

View of landside looking downstream of landside well maintained annual vegetation. Fall 2016.

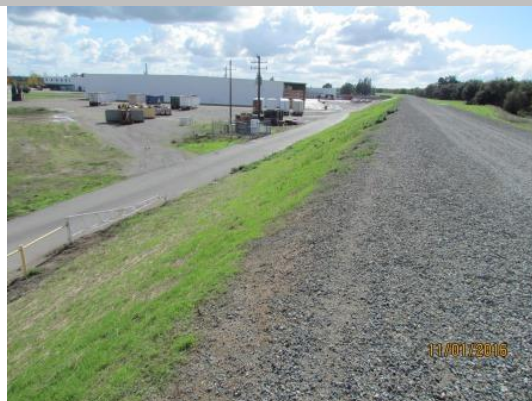
Photo 1 of 1 : FA_2016_RD0784_532_6_20161103_00008.jpg

LM Start	9.21	Rating **	M	Issue No.	6
LM End	9.31	Issue Type +	En	Location *	LS
Category	Earthen Levee			GPS Latitude/Longitude	
				Start	End
Item	Encroachments			39.006523 °	39.005235 °
				-121.577843 °	-121.578286 °
DWR ID	DWR_RD0784_02_f_2012_6				
Comment Code					
MA : Material					
Inspector Comment					
Un-permitted paving at levee toe. Fall 2016.

View looking downstream on the land side of un-permitted paving. Fall 2016.

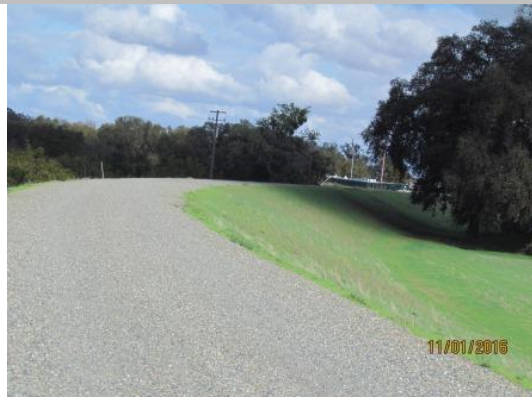
Photo 1 of 1 : FA_2016_RD0784_533_3_20161103_00002.jpg

View of waterside looking upstream at well maintained annual vegetation. Fall 2016.

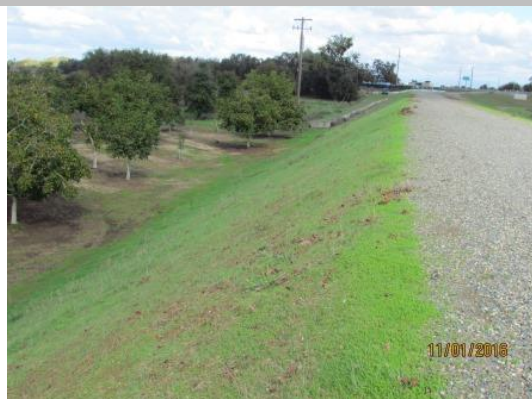
Photo 1 of 1 : FA_2016_RD0784_533_1_20161103_00003.jpg

View of landside looking upstream of landside well maintained annual vegetation. Fall 2016.

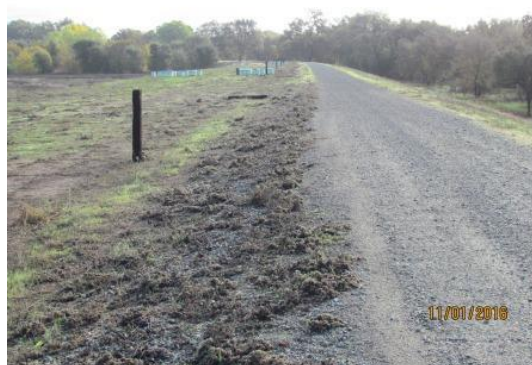
Photo 1 of 1 : FA_2016_RD0784_534_3_20161103_00001.jpg

View of landside looking upstream of landside well maintained annual vegetation. Fall 2016.

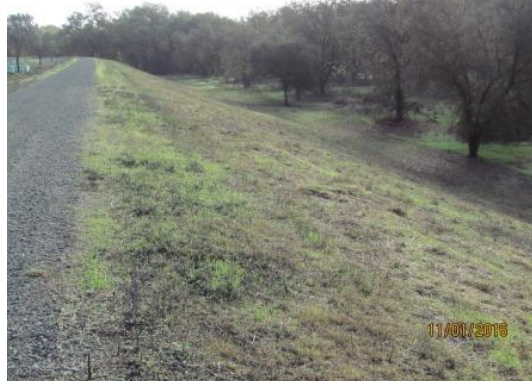
Photo 1 of 1 : FA_2016_RD0784_534_2_20161103_00002.jpg

View of waterside looking upstream at well maintained annual vegetation. Fall 2016.

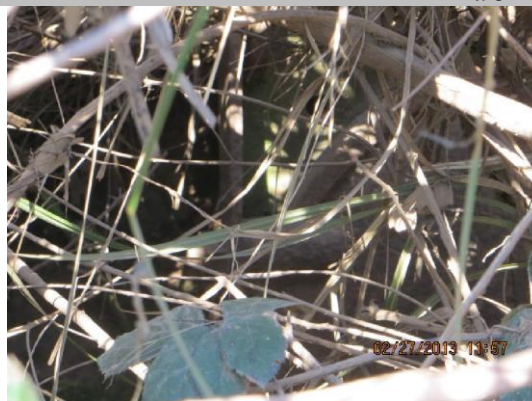
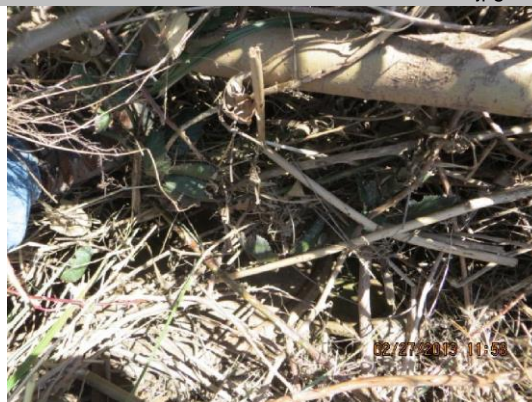
FS_ID:50165
DS_ID:18627
EP_NO: N/A
Repair Type: Non-Urgent
Crossing Status: Found
UCIP Comments: 09/22/2016 - vegetation at inlet of pipe has been cleared by owner. photos added showing pipe inlet. (T.
Hatch/UCIP)08/09/2016 - vegetation partially obscuring outlet on WS.
Heavy vegetation on landside (LS) limiting inspection of inlet. Owner asked by RD0784 to clear vegetation and debris. (T.
Hatch/UCIP)11/1/2015 - Flap Gate has been cleared as of 12/9/2014 and again during summer of 2015 (P. Meagher/RD0784)2/27/2013 - Flap gate blocked by vegetation on WS toe. Unable to locate inlet. (W. Wylie/UCIP)
FIELD_STRUCT_DESC: 18-inch corrugated metal drainage pipe through the levee, 20-feet below the crown. A gate valve is on the waterside (WS). {Additional Reference(s): USACE Sacramento O&M Manual 145, August 1955 (sta 4+96). USACE Sacramento As-built Drawings, 2-4-106, Exhibit B, Sheet 2, July 1944 (sta 4+96)].

Flap gate blocked by vegetation on WS Toe.

Flap gate blocked by vegetation on WS toe.

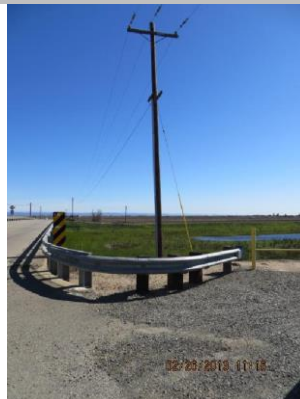
Photo 1 of 2 : UCIP_FA_2016_46600_54244.jpg

LM Start	3.59	Rating **	M	Issue No.	6
LM End	3.59	Issue Type +	En	Location *	WS
Category	Supplemental			GPS Latitude/Longitude	
				Start	End
Item	DWR UCIP Field Study			39.026347 °	39.026347 °
				-121.542343 °	-121.542343 °
DWR ID					
Comment Code					
Inspector Comment					
FS_ID:46600 DS_ID:22686 EP_NO: N/A Repair Type: Non-Urgent Crossing Status: Found UCIP Comments: No permit identified for crossing. FIELD_STRUCT_DESC: Communication line through the levee at unknown depth on downstream side of bridge. FS Date: 9/11/2015 9:25:57 AM

Communication line at base of JP on WS slope.

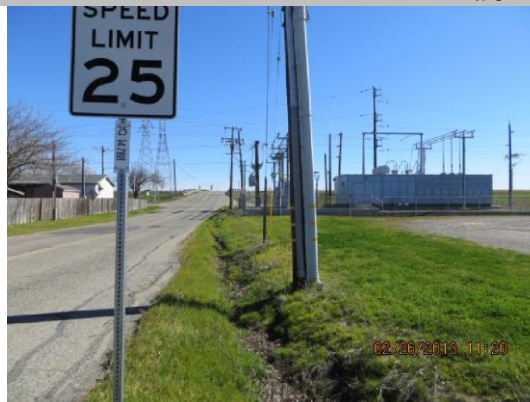
Photo 2 of 2 : UCIP_FA_2016_46600_54243.jpg

Communication line runs on south side of Plumas Arboga Road to JP approximately 400-feet West of levee crown.

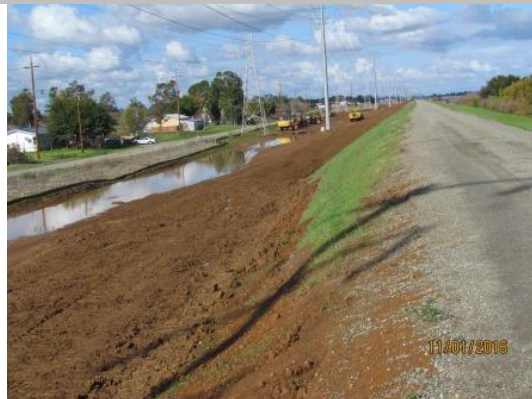
Photo 1 of 2 : FA_2016_RD0784_181_5_20161103_00009.jpg

LM Start	3.60	Rating **	A	Issue No.	5
LM End	5.84	Issue Type +	Ma	Location *	LS
Category	Earthen Levee			GPS Latitude/Longitude	
				Start	End
Item	Slope Stability			39.026503 °	39.058462 °
				-121.542349 °	-121.543125 °
DWR ID	DWR_RD0784_04_f_2016_5				
Comment Code					
S1 : Repair slope instability.					
Inspector Comment					
This section of levee on the landside is under construction with Permit Number 19020-1 to construct a stability berm and all weather access road. Fall 2016.

View of landside looking upstream. This section of levee on the landside is under construction with Permit Number 19020-1 to construct a stability berm and all weather access road. Fall 2016.

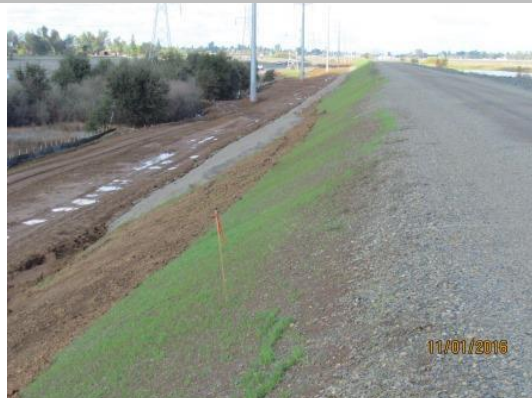
Photo 2 of 2 : FA_2016_RD0784_181_5_20161103_00010.jpg

Second view of landside looking upstream. This section of levee on the landside is under construction with Permit Number 19020-1 to construct a stability berm and all weather access road. Fall 2016.

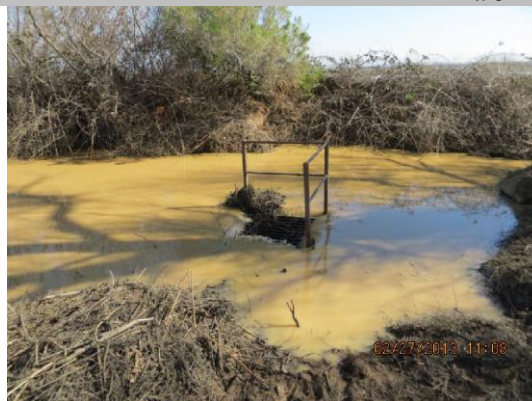
Photo 1 of 2 : UCIP_FA_2016_46592_54246.jpg

FS_ID:46592
DS_ID:18591
EP_NO: N/A
Repair Type: Non-Urgent
Crossing Status: Found
UCIP Comments: No handle or access to slide gate on LS toe.
FIELD_STRUCT_DESC: 30-inch CM pipe through the levee 23.7 feet below the crown. Flap gate on the waterward end. Slide gate in concrete drop inlet on the landward side. Originally included in O+M manual (1955).
FS Date: 9/11/2015 9:05:55 AM

Concrete drop-inlet at LS toe.

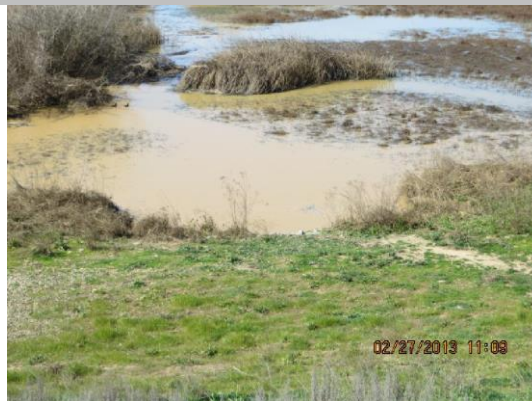
Photo 2 of 2 : UCIP_FA_2016_46592_54245.jpg

Outlet with riprap on WS toe.

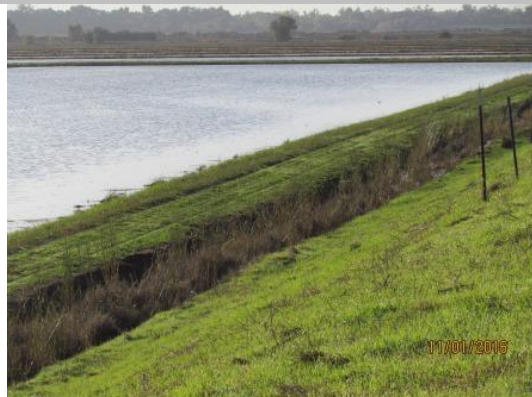
Photo 1 of 1 : FA_2016_RD0784_182_10_20161103_00024.jpg

View of landside looking downstream at the ditch that is along the levee toe. Fall 2016.

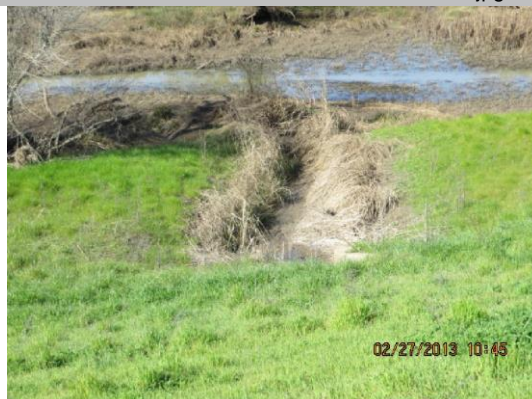
Photo 1 of 2 : UCIP_FA_2016_46604_54249.jpg

LM Start	1.86	Rating **	M	Issue No.	16
LM End	1.86	Issue Type +	En	Location *	LS
Category	Supplemental			GPS Latitude/Longitude	
				Start	End
Item	DWR UCIP Field Study			39.000975 °	39.000975 °
				-121.537779 °	-121.537779 °
DWR ID					
Comment Code					
Inspector Comment					
FS_ID:46604					
DS_ID:18588					
EP_NO: N/A					
Repair Type: Non-Urgent					
Crossing Status: Found					
UCIP Comments: Inlet burried. Good candidate for video inspection as pipe is corroded.					
FIELD_STRUCT_DESC: 18-inch CM drain pipe through the levee, 14.5 feet below the crown. Flap gate on the waterward end. Concrete "U" headwall on the waterward side. Originally included in O+M manual (1955).					
FS Date: 9/11/2015 9:36:14 AM

Drainage outlet on WS toe.

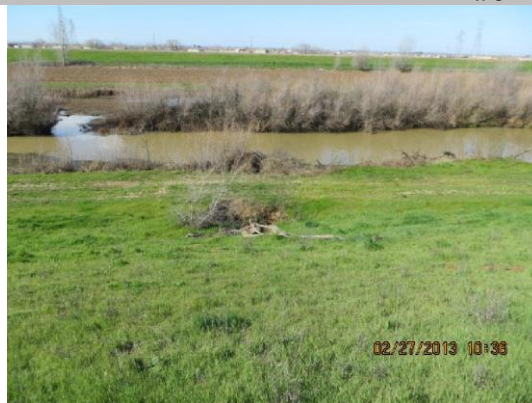
Photo 1 of 2 : UCIP_FA_2016_46603_54252.jpg

LM Start	2.04	Rating **	M	Issue No.	15
LM End	2.04	Issue Type +	En	Location *	LS
Category	Supplemental			GPS Latitude/Longitude	
				Start	End
Item	DWR UCIP Field Study			39.003643 °	39.003643 °
				-121.538292 °	-121.538292 °
DWR ID					
Comment Code					
Inspector Comment					
FS_ID:46603 DS_ID:18587 EP_NO: N/A Repair Type: Non-Urgent Crossing Status: Found UCIP Comments: Erosion at outlet may or may not be an issue. FIELD_STRUCT_DESC: 18-inch CM drain pipe through the levee, 14.5 feet below the crown. Flap gate on the waterward end. Concrete "U" headwall on the waterward side. PVC weir on inlet. Originally included in O+M manual (1955). FS Date: 9/11/2015 9:34:58 AM

Concrete U-shaped outlet on WS toe.

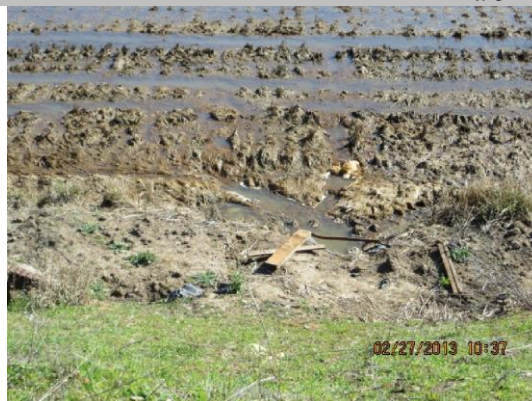
Photo 2 of 2 : UCIP_FA_2016_46603_54251.jpg

LM Start	2.04	Rating **	M	Issue No.	15 (cont)
LM End	2.04	Issue Type +	En	Location *	LS
Category	Supplemental			GPS Latitude/Longitude	
				Start	End
Item	DWR UCIP Field Study			39.003643 °	39.003643 °
				-121.538292 °	-121.538292 °
DWR ID					
Comment Code					
Inspector Comment					
FS_ID:46603 DS_ID:18587 EP_NO: N/A Repair Type: Non-Urgent Crossing Status: Found UCIP Comments: Erosion at outlet may or may not be an issue. FIELD_STRUCT_DESC: 18-inch CM drain pipe through the levee, 14.5 feet below the crown. Flap gate on the waterward end. Concrete "U" headwall on the waterward side. PVC weir on inlet. Originally included in O+M manual (1955). FS Date: 9/11/2015 9:34:58 AM

Inlet with PVC weir on LS toe.

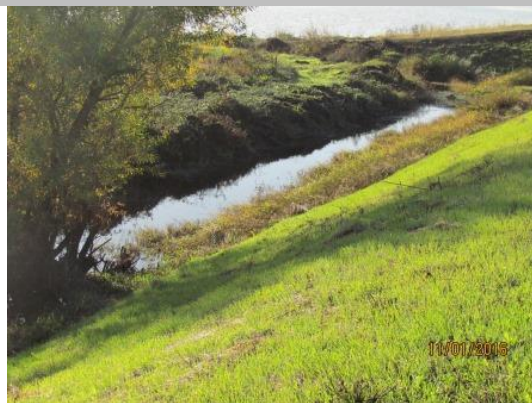
Photo 1 of 1 : FA_2016_RD0784_182_9_20161103_00025.jpg

LM Start	2.11	Rating **	M	Issue No.	9
LM End	3.07	Issue Type +	En	Location *	LS
Category	Earthen Levee			GPS Latitude/Longitude	
				Start	End
Item	Encroachments			39.004562 °	39.015593 °
				-121.538482 °	-121.528533 °
DWR ID	DWR_RD0784_05_s_2012_9				
Comment Code					
DT : Ditch					
Inspector Comment					
Ditch at toe of slope. Fall 2016.

View of landside looking downstream at the ditch that is along the levee toe. Fall 2016.

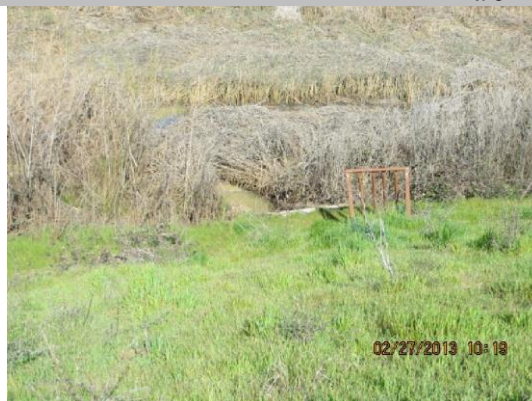
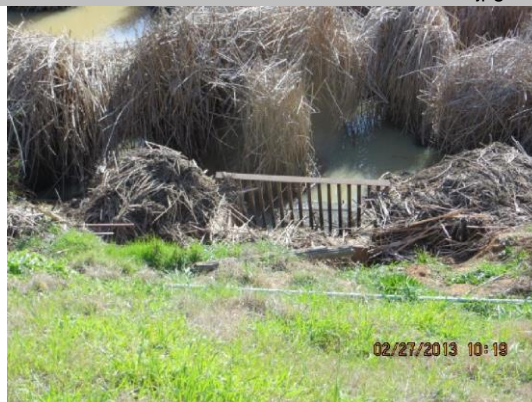
UCIP Comments: 7/29/2016 - Erosion scarp on LS cut into levee shoulder starting at inlet headwall. Cavity failure on WS shoulder approximately 2-feet in diameter and several feet in depth. (T. Hatch/UCIP)11/01/2015 - The concrete box weir structure on the landside inlet has slumped off the end of the pipe. DWR Chief inspector George Willie inspected the site on 8/13/2015 with Steve Fordice, General Manager of RD784. (P. Meagher - RD784)

Outlet on WS.

Inlet on LS.

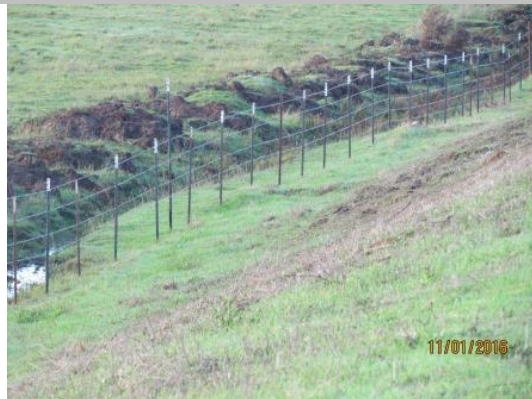
Photo 1 of 1 : FA_2016_RD0784_182_5_20161103_00031.jpg

View of fence along the landside toe looking downstream. Fall 2016.

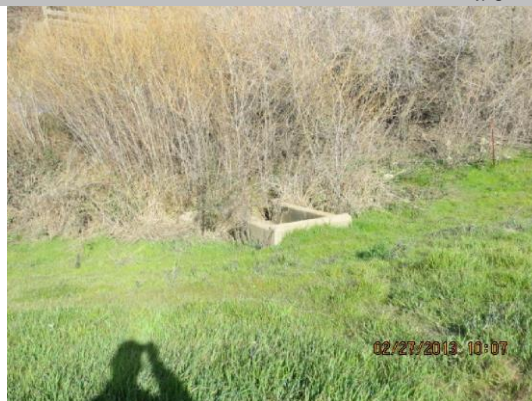
Photo 1 of 2 : UCIP_FA_2016_46601_54261.jpg

LM Start	3.06	Rating **	M	Issue No.	14
LM End	3.06	Issue Type +	En	Location *	LS
Category	Supplemental			GPS Latitude/Longitude	
				Start	End
Item	DWR UCIP Field Study			39.015549 °	39.015549 °
				-121.528590 °	-121.528590 °
DWR ID					
Comment Code					
Inspector Comment					
FS_ID:46601 DS_ID:18596 EP_NO: N/A Repair Type: Non-Urgent Crossing Status: Found UCIP Comments: Pipe has been sliplined with PVC, but the liner appears to be eroding at outlet and may be disjointed internal to the levee. See pic. Good candidate for video inspection. FIELD_STRUCT_DESC: 12-inch CM drain pipe through the levee, 12.0 feet below the crown. Flap gate and concrete "U" headwall on the waterward side. PVC weir on inlet at LS toe. Originally included in O+M manual (1955). FS Date: 9/11/2015 9:26:56 AM

Concrete U-shaped headwall on WS toe.

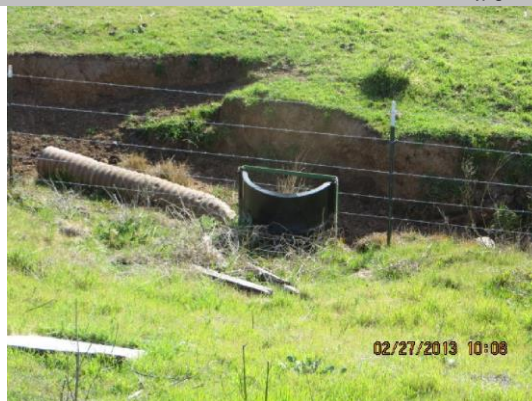
Photo 2 of 2 : UCIP_FA_2016_46601_54260.jpg

LM Start	3.06	Rating **	M	Issue No.	14 (cont)	
LM End	3.06	Issue Type +	En	Location *	LS	
Category	Supplemental			GPS Latitude/Longitude		
				Start		End
Item	DWR UCIP Field Study			39.015549 °		39.015549 °
				-121.528590 °		-121.528590 °
DWR ID						
Comment Code						
Inspector Comment						
FS_ID:46601 DS_ID:18596 EP_NO: N/A Repair Type: Non-Urgent Crossing Status: Found UCIP Comments: Pipe has been sliplined with PVC, but the liner appears to be eroding at outlet and may be disjointed internal to the levee. See pic. Good candidate for video inspection. FIELD_STRUCT_DESC: 12-inch CM drain pipe through the levee, 12.0 feet below the crown. Flap gate and concrete "U" headwall on the waterward side. PVC weir on inlet at LS toe. Originally included in O+M manual (1955). FS Date: 9/11/2015 9:26:56 AM

PVC weir on LS toe. Notice pipe debris from repair.

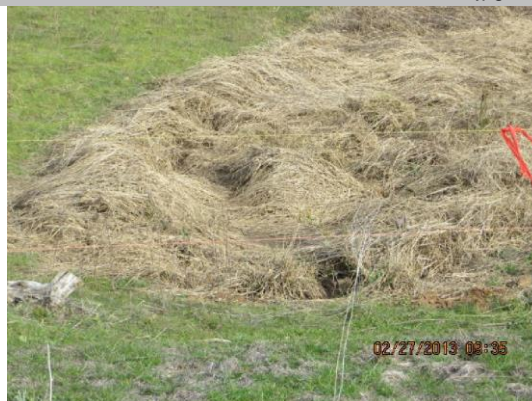
Photo 1 of 2 : UCIP_FA_2016_50676_56705.jpg

FS_ID:50676
DS_ID:18593
EP_NO: N/A
Repair Type: Non-Urgent
Crossing Status: Found
UCIP Comments: 11/14/2016 - Photos added of exposed flap gate on WS and possible inlet location on LS. Condition remains as Non-Urgent because of inlet not being fully operable. Unknown if pipe will operate as designed during high water or if it is full of sediment. 11/01/2015 - Waterside Flap Gate Uncovered. Photo sent to DWR Matt Hoffman on 3/3/2014. Fresh photo sent to DWR Pavel Kazi on 9/9/2015. Landside toe has never been able to be located. Requesting DWR inspector to change the status of this issue to "No Action Needed". (P.Meagher - RD784). Pipe buried on LS toe and flap gate is blocked by soil on WS toe. (W. Wylie - UCIP Inspector).
FIELD_STRUCT_DESC: 18-inch CM pipe through the levee, 10.0 feet below the crown. Flap gate on the waterward end. Originally included in O+M manual (1955).
FS Date: 10/9/2015

Outlet on WS toe .

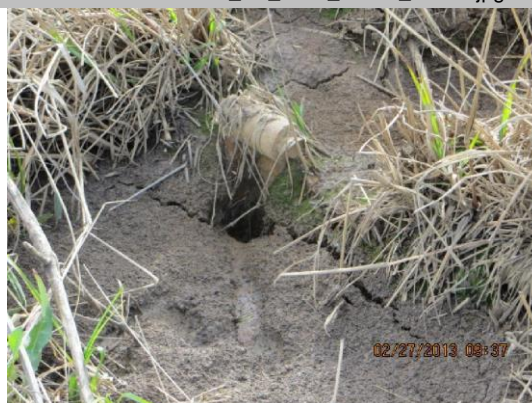
Photo 2 of 2 : UCIP_FA_2016_50676_56704.jpg

Flap gate buried in soil at outlet on WS toe.

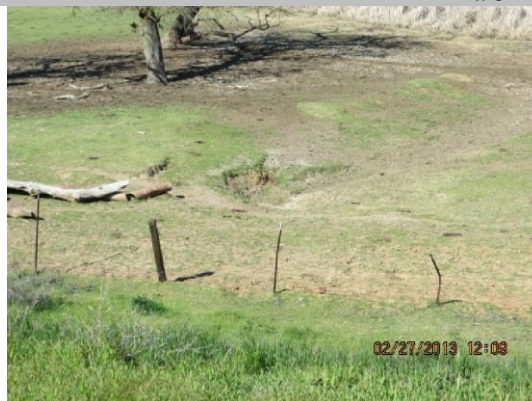
Photo 1 of 2 : UCIP_FA_2016_46776_54267.jpg

INlet at LS toe.

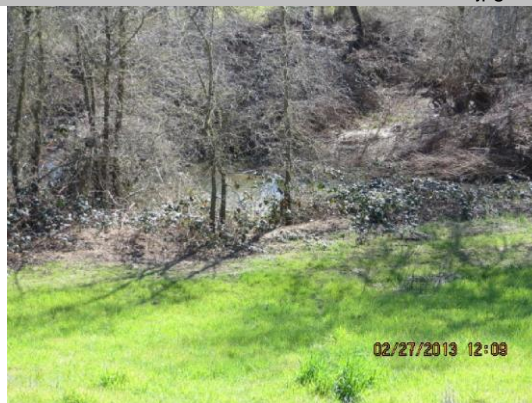
Photo 2 of 2 : UCIP_FA_2016_46776_54266.jpg

Outlet at WS stream bank.

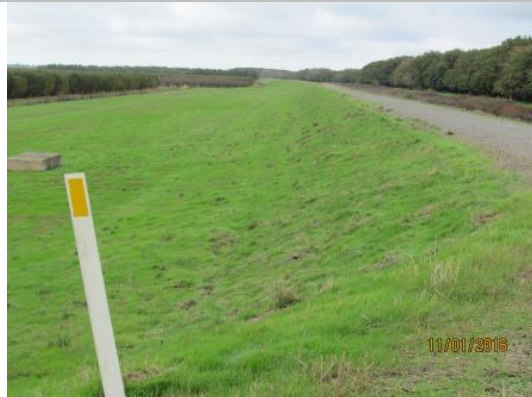
Photo 1 of 1 : FA_2016_RD0784_184_2_20161103_00005.jpg

View of landside looking downstream of landside well maintained annual vegetation. Fall 2016.

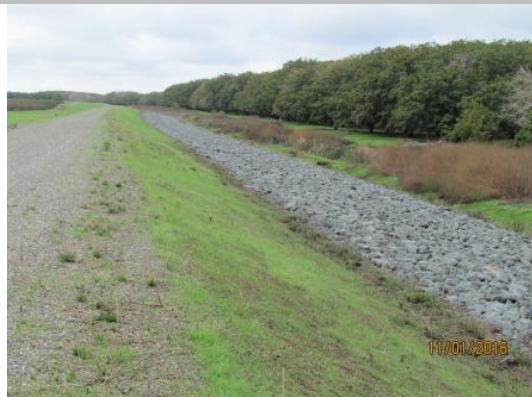
Photo 1 of 1 : FA_2016_RD0784_184_3_20161103_00004.jpg

View of waterside looking downstream at well maintained annual vegetation. Fall 2016.

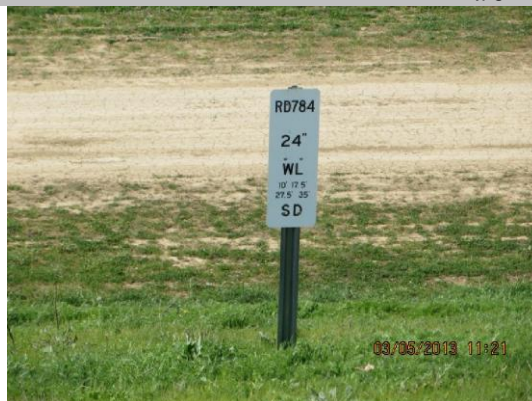
Photo 1 of 2 : UCIP_FA_2016_46591_27163.jpg

Paddle marker on WS toe.

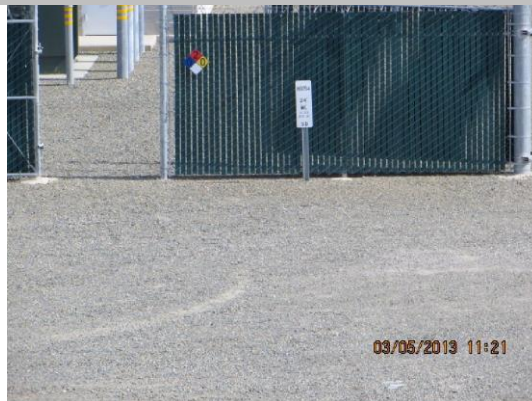
Photo 2 of 2 : UCIP_FA_2016_46591_27162.jpg

Paddle marker on LS toe at pumping plant fence.

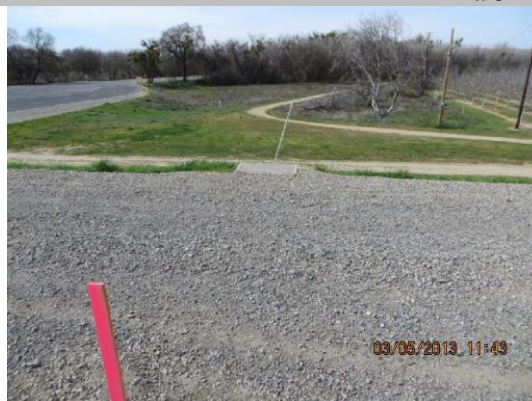
Photo 1 of 2 : UCIP_FA_2016_46586_27161.jpg

Christy box on WS shoulder.

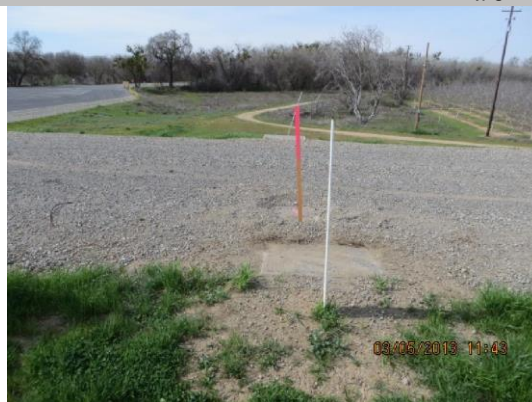
Photo 2 of 2 : UCIP_FA_2016_46586_27160.jpg

Christy box on LS shoulder.
